A simulated bushfire test report

An external construction tested in accordance with AS 1530.8.1:2018

Product: StateWall® Render System

Bushfire attack level (BAL) exposure: 29kW/m² Crib class: AA

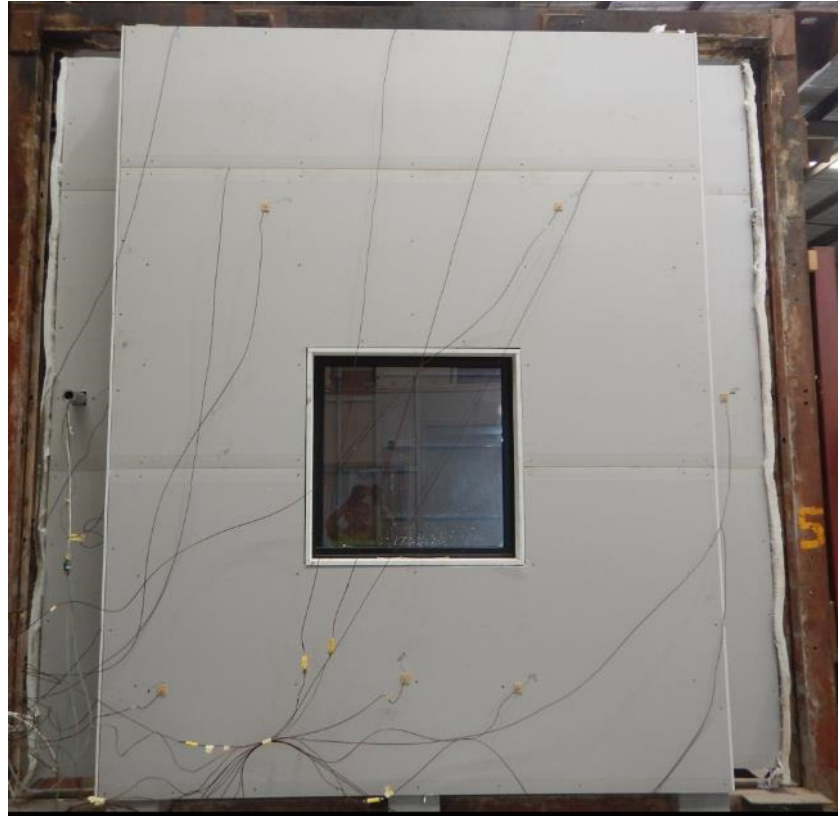
Figure 14 Unexposed face of specimen before the start of the bush fire test

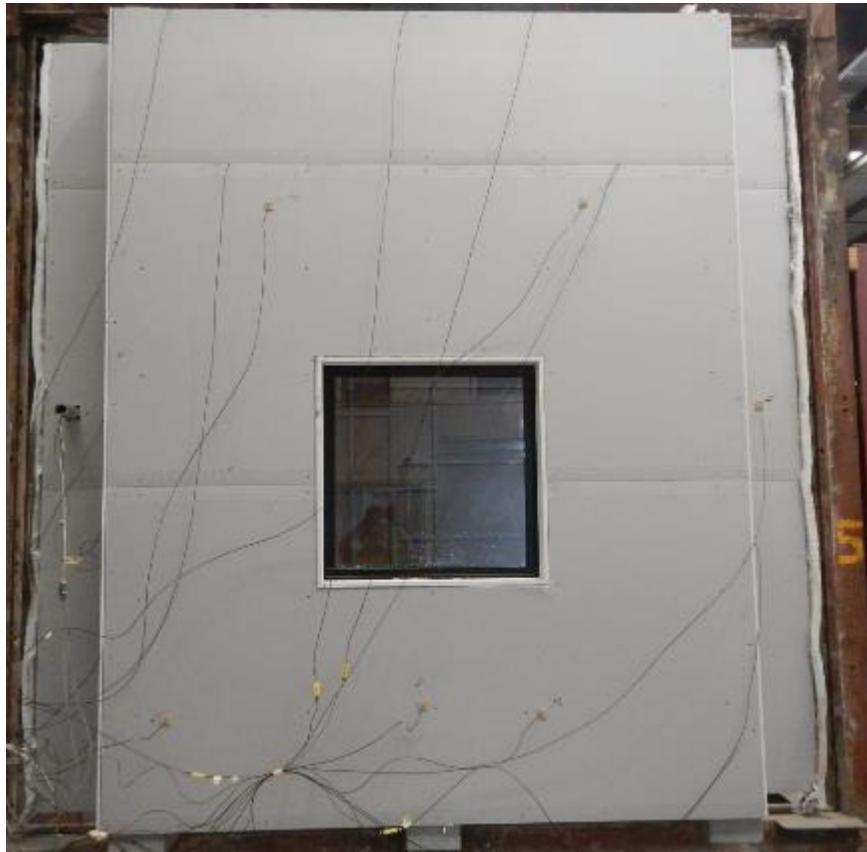
Figure 16 Unexposed face of specimen at the end of the bush fire test

60	00	No further changes to the specimen observed. The bushfire test was stopped in accordance with the procedures of AS 1530.8.1-2018.

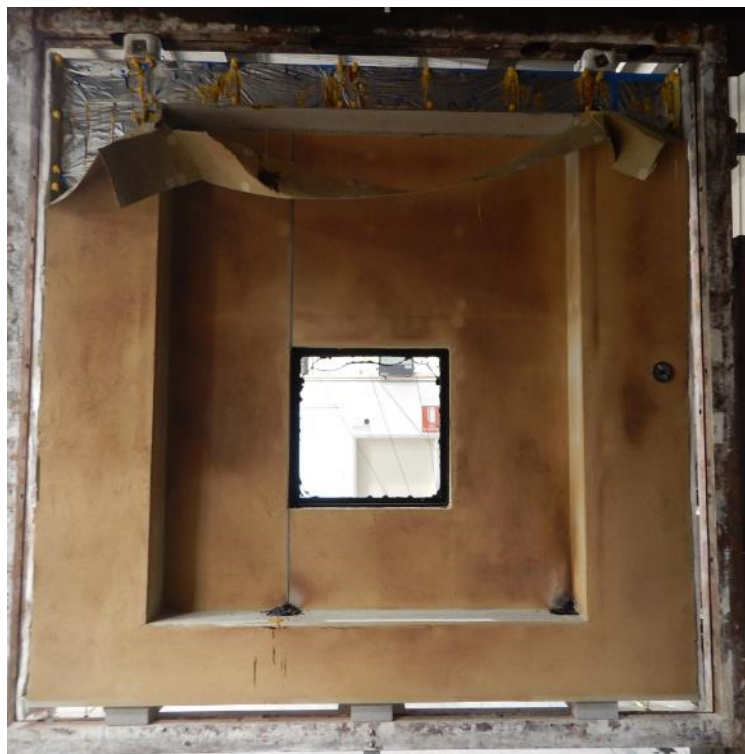
Figure 17 Exposed face of the specimen at the end of the bush fire test

Time		Observation
Min	Sec	
00	00	Bushfire test commenced and two burning cribs were placed against the specimen.
00	03	The screen was removed, and the specimen was exposed to the radiant heat profile for BAL 29 as specified in AS 1530.8.1-2018.
00	51	The walls adjacent to the south crib had discoloured.
01	20	Light smoke emission was evident from the face of the specimen.
01	30	Cracking of render below the sill on the front face.
02	13	Entire front face of the specimen had discoloured.
02	20	The intumescent seal around the sill of the window frame had begun to expand.
02	37	Render along the head of the specimen had partially detached.
03	27	The EPS had melted away along the head and exposed the sarking.
10	00	Screen positioned in front of the furnace and exposure to the radiant heat profile for BAL 29 ceased.
13	00	Both the cribs had self-extinguished and were no longer flaming. No further flaming evident from the specimen up to the point of test termination.
